Des 1801500 CE-4

Appendix F

Water Resources

Waters Report
I-65 at 109th Avenue in Lake County, Indiana
Interchange Modification Project
Des. No. 1801500

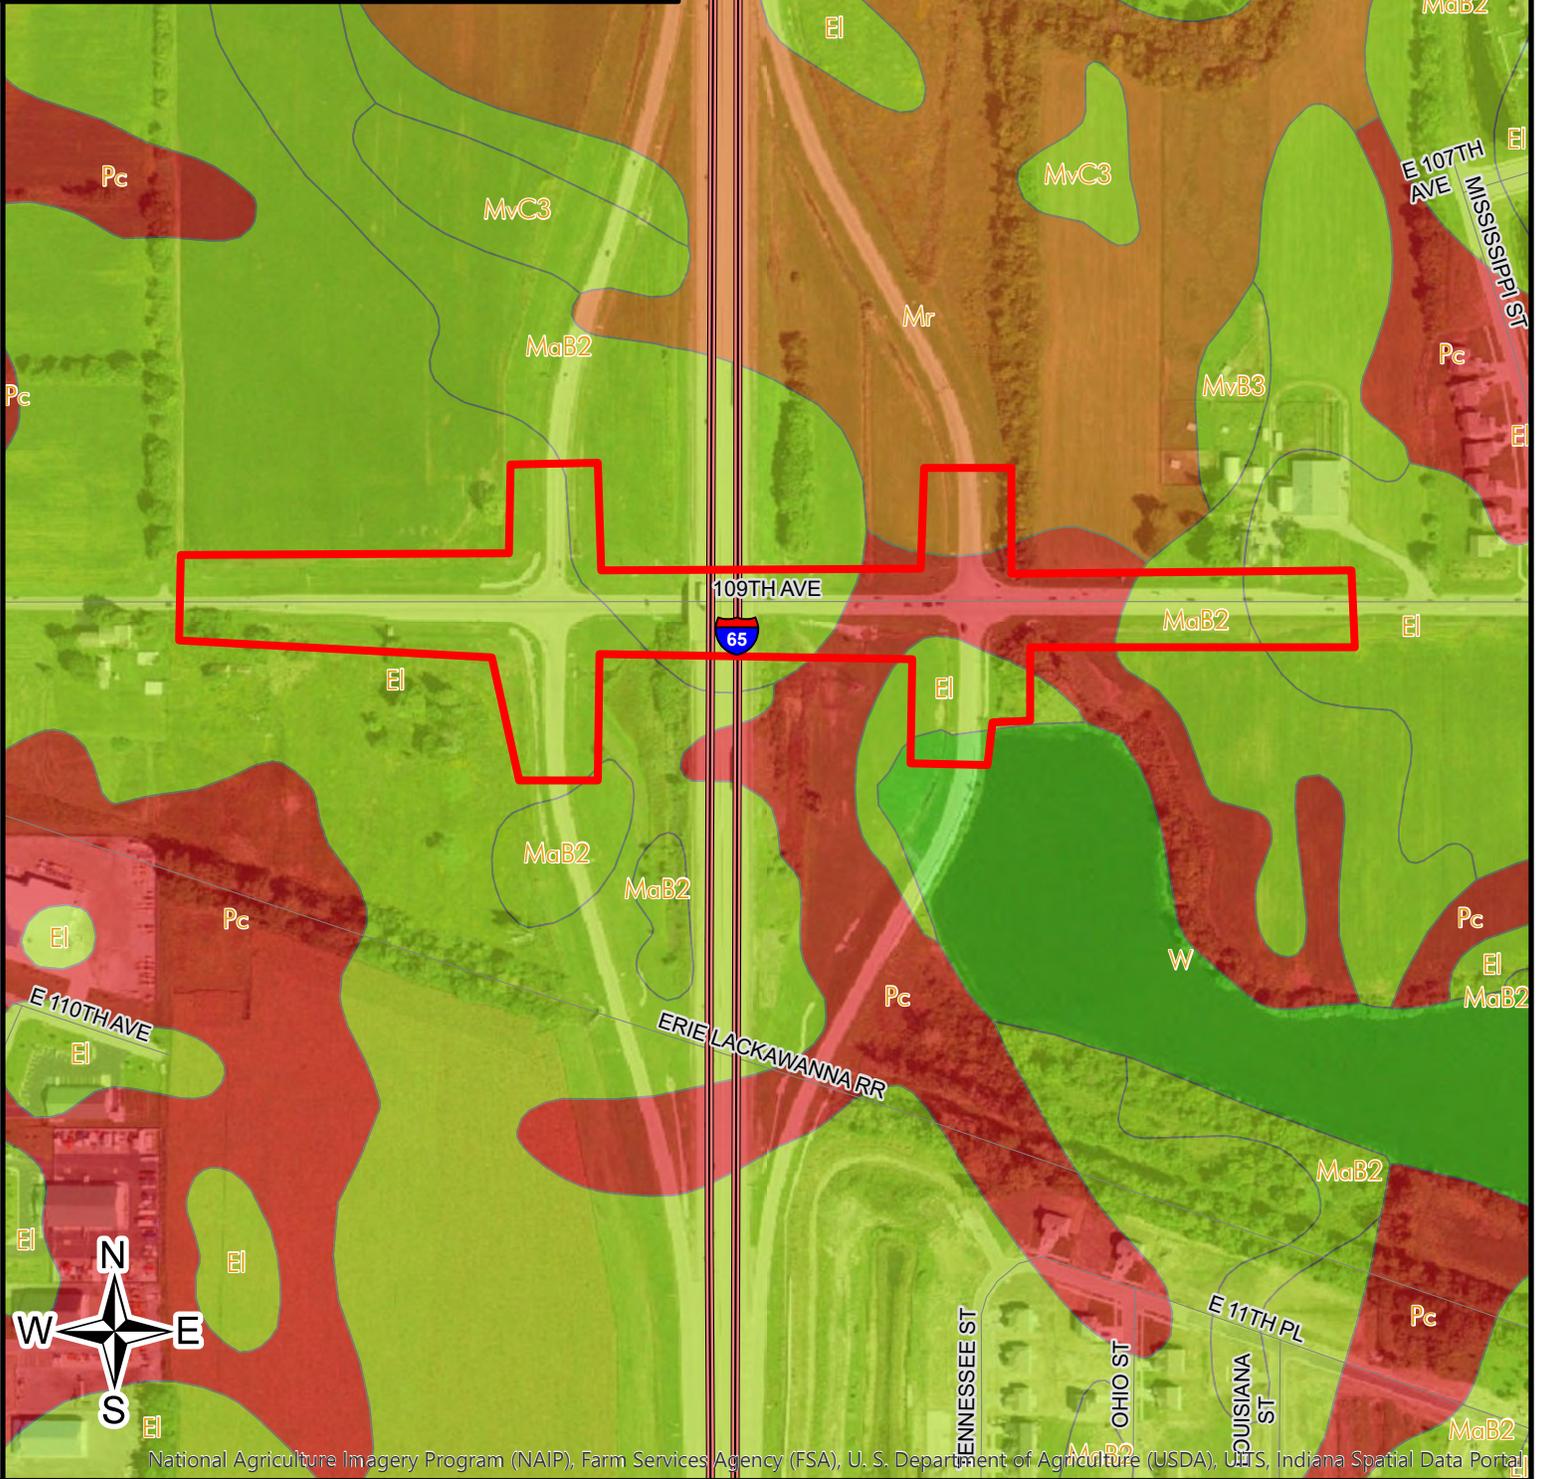
Soil Survey Map
 Interchange Modification Project
 I-65 at 109th Avenue
 Des. No. 1801500
 Lake County, Indiana
 Source: USDA Soil Survey

According to the Soil Survey Geographic (SSURGO) Database for Lake County, Indiana, the investigated area does contain soil areas with nationally listed hydric soils. Soils within and near the investigated area are characterized by moderately well drained to poorly drained hydric soils.

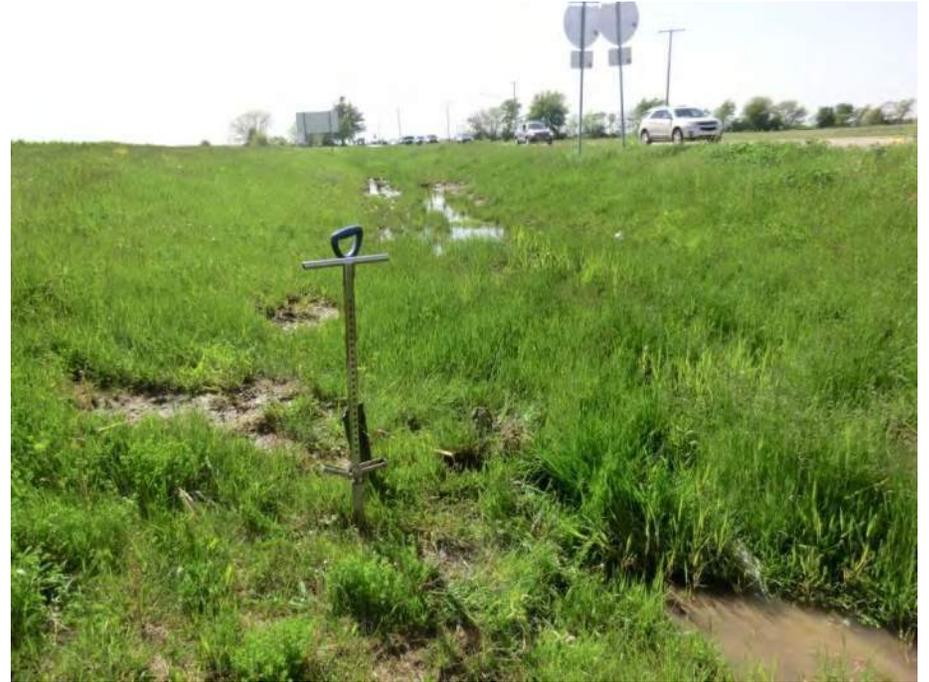
Sample Point 1 (SP1) was taken in an emergent roadside ditch wetland in the southwest quadrant of the western interchange. This site was not mapped on the attached NWI map. Vegetation at this sample point was dominated by Kentucky Bluegrass (*Poa pratensis*, FAC). This vegetation community passed the dominance test and prevalence index for hydrophytic vegetation. Hydrology at SP1 met the conditions of Surface Water (A1), High Water Table (A2), and Saturation (A3). Soils at SP1 were 10 YR 2/1 (100%) from 0-4 inches, 10 YR 6/1 (90%) with redox concentrations of 10 YR 4/8 (10%) from 4-20 inches. All soil horizons were clay loam. This met the criteria for Depleted Below Dark Surface (A11) and Depleted Matrix (F3). This sample point met the criteria for hydrophytic vegetation, wetland hydrology, and hydric soils; therefore, it was within a wetland. Wetland 1 is approximately 0.15 acre in size. It is likely considered a Water of the State because it does not exhibit a significant nexus with a traditionally navigable waterway. It is likely considered exempt from isolated permitting requirements because it is under 0.5 acre in area and is an incidental feature of a roadside drainage ditch. The Indiana Department of Environmental Management (IDEM) retains the authority to determine if a wetland is considered exempt. Wetland 1 is considered poor quality due to its lack of biodiversity and habitat for aquatic flora and fauna.

Photo 7. Wetland 1 Facing West

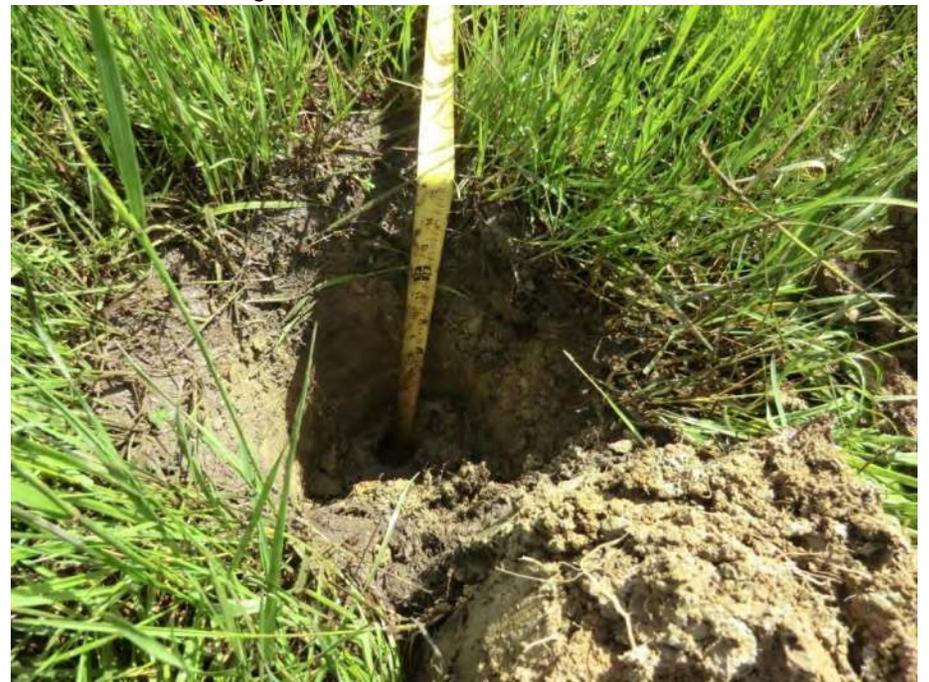
Sample Point 2 (SP2) was taken south of and immediately adjacent to SP1. Vegetation at this sample point was dominated by Tall Fescue (*Schedonorus arundinaceus*, FACU), Kentucky Bluegrass (*Poa pratensis*, FAC), and Red Clover (*Trifolium pretense*, FACU). This vegetation community did not pass the rapid test, dominance test, or prevalence index for hydrophytic vegetation. No hydrology indicators were observed at SP2. Soils at SP2 were 10 YR 3/2 (55%) and 10 YR 2/2 (45%) from 0-12 inches, and 10 YR 2/1 (98%) with redox concentrations of 10 YR 5/8 (2%) from 12-18 inches. A restrictive layer of hardpan was encountered at 18 inches. All soil horizons were clay loam. No wetland criteria were met at this sample point.

Photo 8. Upland 1 Soil

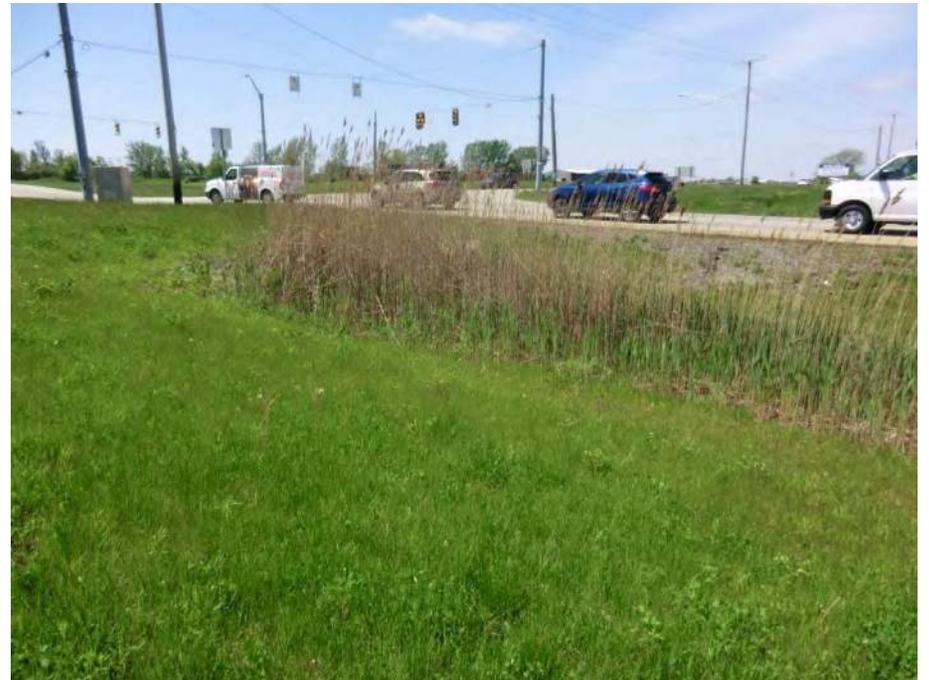
Sample Point 3 (SP3) was taken in a roadside ditch wetland in the northwest quadrant of the western interchange. This site was not mapped on the attached NWI map. Vegetation at this sample point was dominated by Reed Canary Grass (*Phalaris arundinacea*, FACW). This vegetation community passed the rapid test, dominance test, and prevalence index for hydrophytic vegetation. Hydrology at SP3 met the conditions of High Water Table (A2) and Saturation (A3). Soils at SP3 were 10 YR 2/1 (95%) from 0-8 inches with redox concentrations of 2.5 YR 5/8 in the pore lining (5%), and 10 YR 5/1 (90%) with redox concentrations of 10 YR 5/8 (10%) from 8-16 inches. All soil horizons were silty clay. SP3 exhibited Depleted Below Dark Surface (A11) and Depleted Matrix (F3). This sample point met the criteria for hydrophytic vegetation, wetland hydrology, and hydric soils; therefore, it was within a wetland. Wetland 2 is approximately 0.14 acre in size; however, wetland conditions continue beyond the boundary drawn in the attached graphics to Main Beaver Dam Ditch to the north. Wetland 2 is likely a Water of the United States due to its connectivity to Main Beaver Dam Ditch, which is another likely jurisdictional water feature. Wetland 2 is poor quality due to its lack of biodiversity and habitat for aquatic fauna and flora.

Photo 20. Wetland 3 Facing Southwest

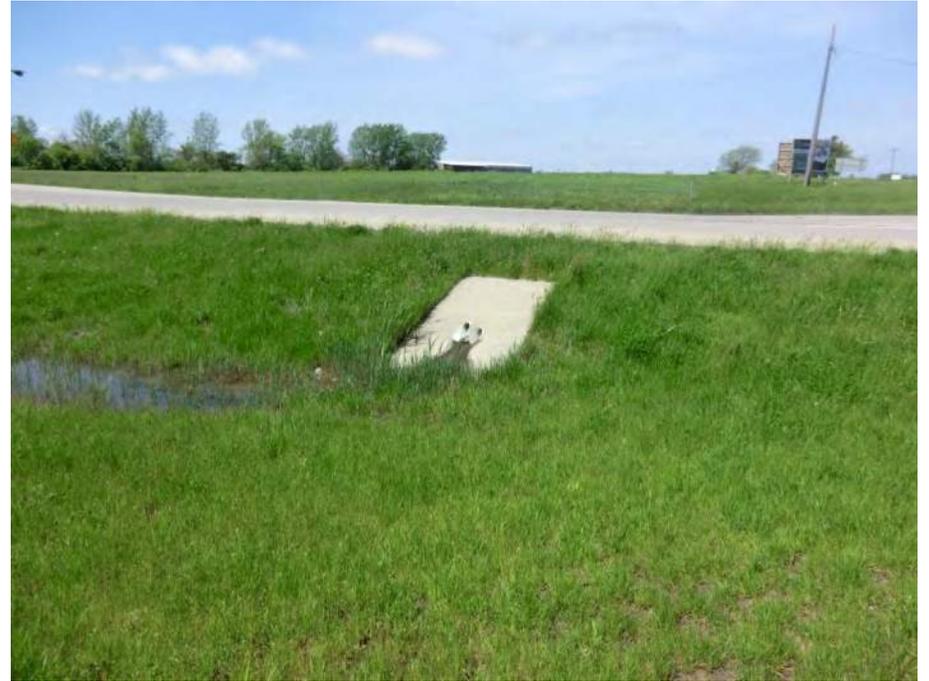
Photo 27. Culvert Conveying Drainage Between Wetland 1 and Wetland 4

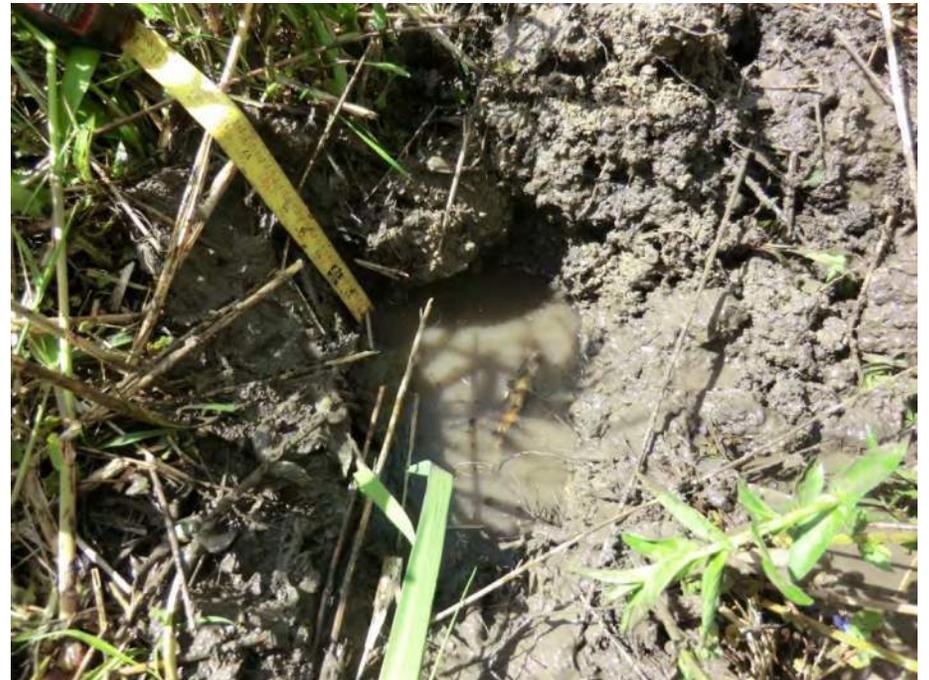
Photo 28. Wetland 4 Soil

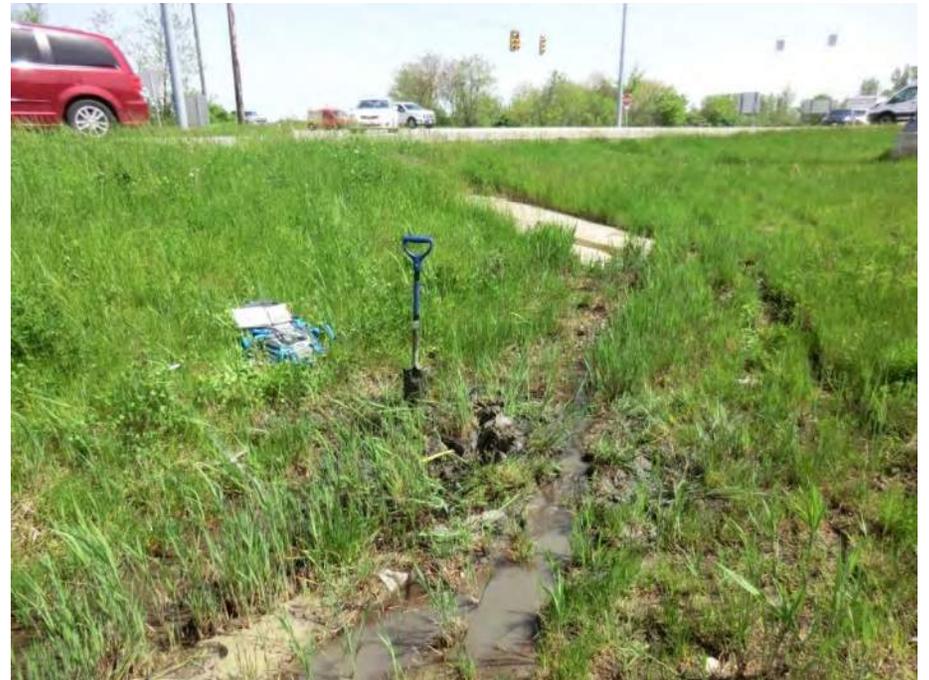
Photo 44. Culvert Conveying Drainage Between Wetland 6 and Wetland 7

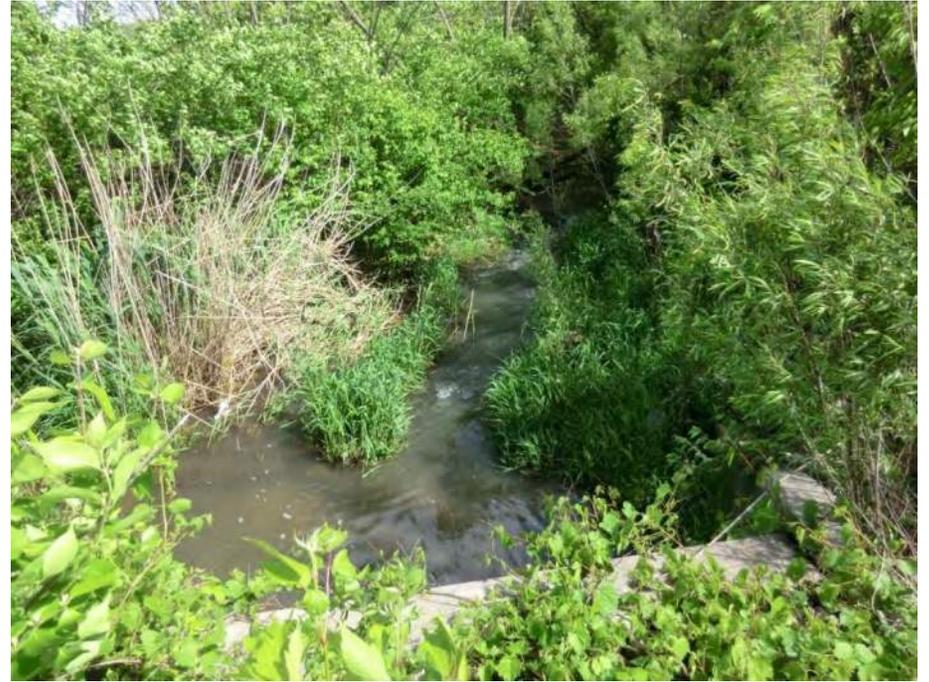
Photo 63. UNT 1 Facing Downstream Side From Culvert

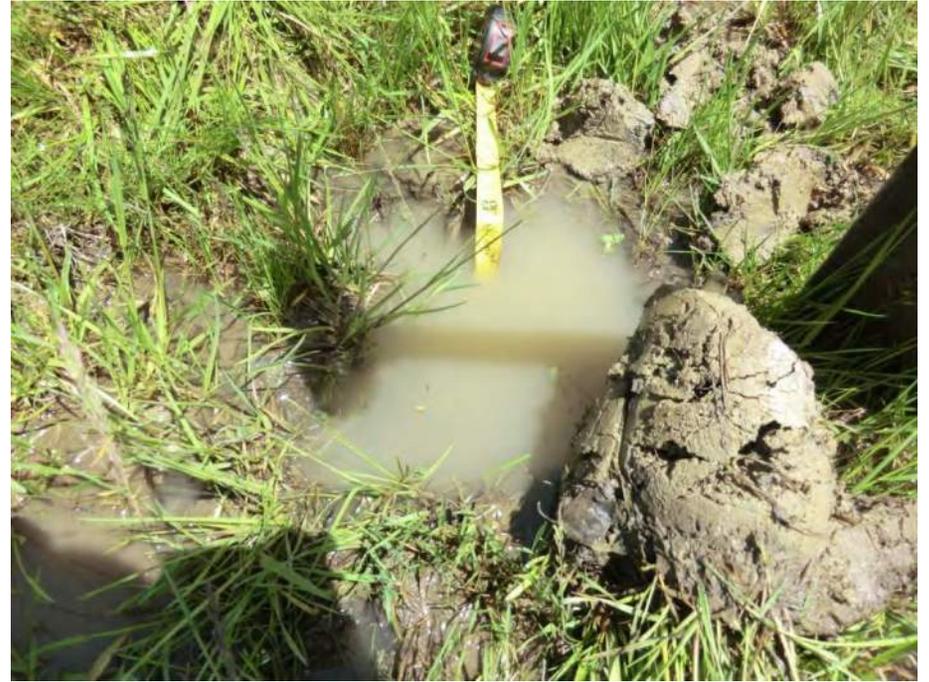
Sample Point 9 (SP9) was taken in a wetland in the southwest quadrant of the eastern interchange. This site was not mapped on the attached NWI map. Vegetation at this sample point was dominated by Common Reed (*Phragmites australis*, FACW), Wide-leaf Cattail (*Typha angustifolia*, OBL), and Lamp Rush (*Juncus effusus*, OBL). This vegetation community passed the rapid test, dominance test, and prevalence index for hydrophytic vegetation. Hydrology at SP9 met the conditions of Surface Water (A1), High Water Table (A2), and Saturation (A3). Soils at SP9 were 10 YR 2/1 (100%) from 0-4 inches with a texture of muck, and 10 YR 5/1 (95%) with redox concentrations of 10 YR 5/8 (5%) in the matrix from 4-12 inches with a texture of silty clay. This met the criteria for Hydrogen Sulfide (A4), 2cm Muck (A10), and Depleted Matrix (F3). This sample point met the criteria for hydrophytic vegetation, wetland hydrology, and hydric soils; therefore, it was within a wetland. Wetland 5 is approximately 1.37 acres in size. It is likely considered a Water of the US because it shares connectivity with Wetland 6 and Wetland 8 through culverts, which are likely jurisdictional water features. Wetland 5 is considered poor quality because it lacks biodiversity and does not provide significant habitat for wetland flora and fauna.

Photo 71. Wetland 9 Soil

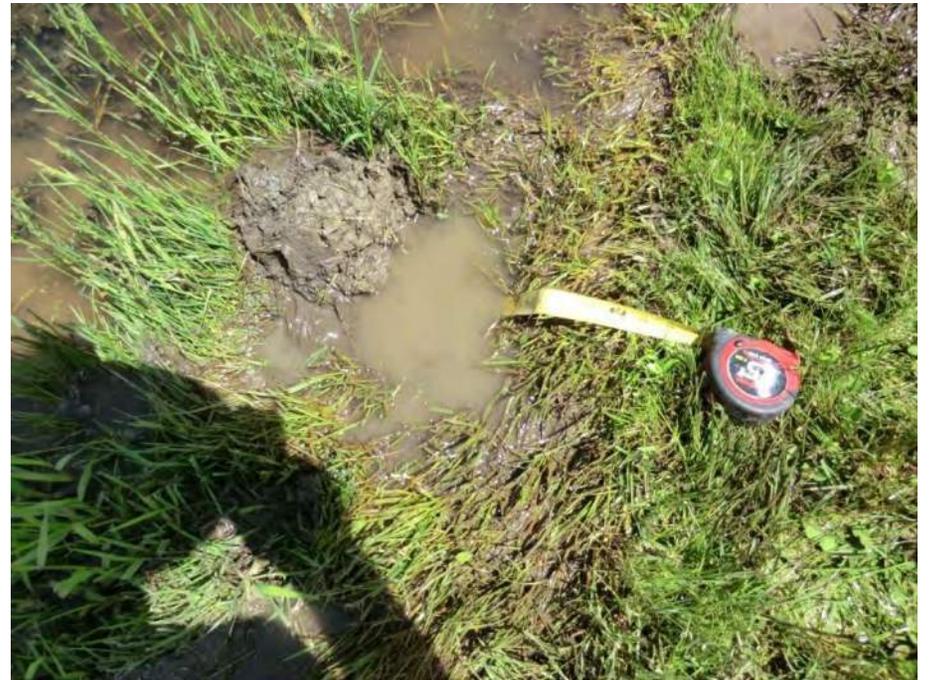
Photo 76. Wetland 10 Soil
